The Incident

The shell of a Feed/Effluent Exchanger on a Naphtha Hydrotreater (NHT) failed catastrophically resulting in an explosion and intense fire which burned for more than 3 hours. The incident fatally injured 7 people (6 operators and 1 shift supervisor) who were working in the immediate vicinity of the ruptured exchanger at the time of the incident.

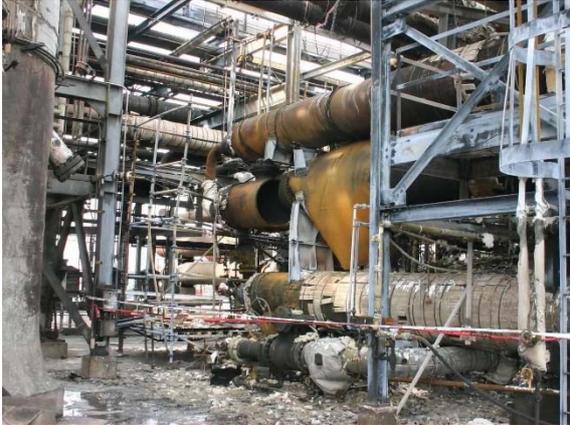
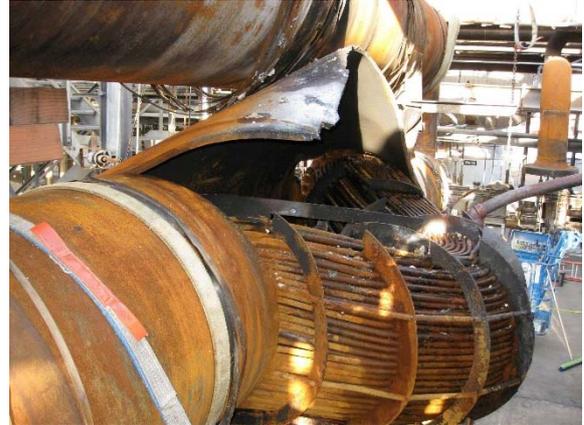
The immediate cause of the explosion and fire was loss of primary containment (LOPC) due to high temperature hydrogen attack (HTHA) of the carbon steel shell of one of the middle exchangers at a point just downstream of the 316 SS partial lining. Critical factors were the high residual stress levels present in areas around the seam welds of the shell due to lack of post-weld heat treatment and presence of additional personnel to assist in restreaming the second train of exchangers after off-line cleaning. Root causes included inaccurate Nelson curve for carbon steel (this curve predicts susceptibility to HTHA as a function of process temperature and hydrogen partial pressure based on observed industry experience), ineffective hazard identification and failure to apply inherently safer design principles.

It is critically important for new and existing units in hydrogen service that equipment is checked against the relevant Nelson Curve for startup, shutdown and transient conditions to identify appropriate mitigation strategies against HTHA. Mitigations may include 1) selection of inherently safer (more HTHA-resistant) materials such as Cr-Mo steels, 2) imposition of strict operating limits, 3) provision of appropriate instrumentation to enable proper monitoring and 4) rigorous enforcement of startup, shutdown and emergency procedures. Note that transient conditions might include gradual changes to operating conditions due to fouling of equipment or deactivation of catalysts.
