The Incident

A major fire erupted and caused extensive property damage including collapse of a 50 m tall vacuum distillation column. The blaze covered an area of approximately 800 m² at one point and eyewitness accounts said that the flames reached 150 m in height and could be seen from several kilometers away. The fire department co-ordination centre sent 23 firefighting vehicles to tackle the fire. The fire was finally extinguished approximately 5½ hours later although some spot fires continued to burn for several more hours. The refinery was only able to run at around 55% capacity for several months until a mothballed vacuum distillation unit that was originally designed for bitumen feedstock production was revamped for vacuum gas oil production as an interim measure to minimise lost production. The revamped unit started up on 14-Feb-07, enabling production to be ramped up to around 72% capacity. The fire-damaged unit was eventually rebuilt and restarted on 20-Jan-08, thereby restoring the refinery to its pre-fire capacity.

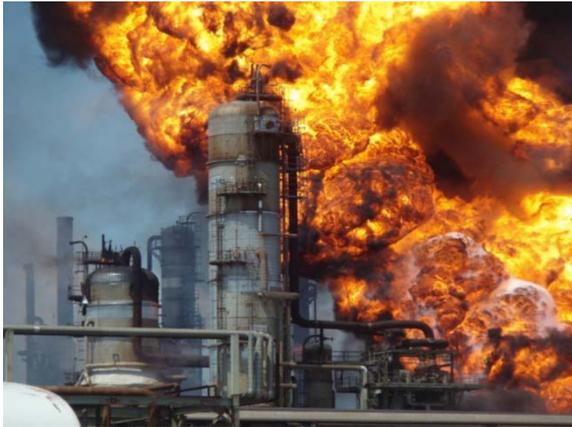
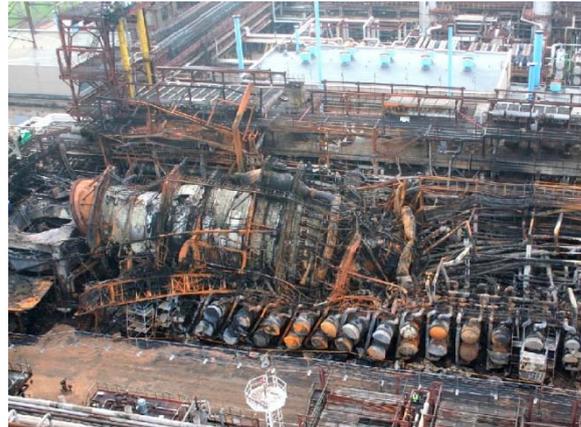
The immediate cause of the fire was loss of primary containment (LOPC) due to rupture of the vacuum bottoms line as a result of thinning caused by a combination of high temperature sulphidation and erosion. A major contributing factor in the destruction of the entire unit was absence of fireproofing on the vacuum distillation column skirt. Root causes included inadequate inspection and inadequate design (incorrect metallurgy of the vacuum bottoms piping).

Sulphidation corrosion (also known as sulphidic corrosion) is a result of naturally occurring sulphur compounds found in crude oils. In the absence of hydrogen, the rate of sulphidation corrosion depends on many factors such as the concentration and type of sulphur compounds present and the fluid temperature and flow rate. Hydrogen sulphide (H₂S) is the most active sulphur species from a corrosion perspective and sulphidation corrosion rates increase rapidly above 260 °C (500 °F), especially for carbon steel. Sulphidation corrosion can be localised or general in nature although the majority of cases exhibit general thinning. If general thinning occurs over a large enough area, a rupture of the pressure containment envelope (in this case piping) can occur, resulting in a release of a large quantity of material to atmosphere. High chrome alloys should be specified for all wetted piping or equipment operating in sour service at temperatures above 260 °C (500 °F) because they offer excellent resistance to high temperature sulphidation.

Fireproofing is a passive fire protection system which enables a degree of fire exposure to be tolerated while a fire is being brought under control and extinguished without major collapse or further failures that could lead to the spread of burning liquids and exacerbate property damage. Since vacuum distillation columns contain large inventories of flammable hydrocarbons above their autoignition temperature, fireproofing should be applied on external surfaces of the column support skirt. Consideration should also be given to applying fireproofing on the internal surfaces of the column support skirt if it contains any flanges or valves. However, fireproofing should not be applied to the bottom head of the column even if the internal surfaces of the skirt are being fireproofed.
