The Incident

A Sulphur Recovery Unit (SRU) suffered an unplanned shutdown triggered by flame failure following an internal leakage in a reaction furnace waste heat boiler (WHB). The resulting loss of SRU capacity forced a shutdown of one gas oil hydrotreater and reduced throughput at two more gas oil hydrotreaters. If another of the SRUs had been off-line for maintenance at the time of this incident, production losses would have been significantly higher.

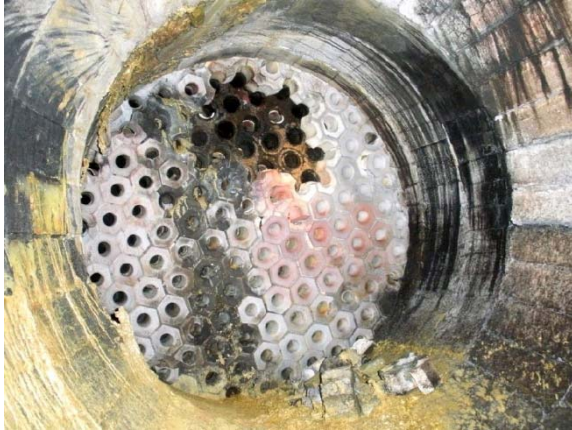
The immediate cause of the SRU shutdown was flame failure. A critical factor was a tube leak caused by overheating and accelerated corrosion of the tube to tubesheet weld (the leak got progressively worse and eventually blew back through that tube, pushing ferrules out around the tube end of the leaking tube). The root cause was inadequate control.

An integrity operating window (IOW) limit should be set to limit the fraction of natural gas fired in order to avoid exceeding overheating the reaction furnace and waste heat boiler. Nitrogen should be available to quench the reaction furnace temperature. A dual function infrared thermometer (pyrometer) capable of simultaneous gas and refractory temperature measurement is the preferred method of temperature measurement as the pyrometer can be taken out of service for calibration with the furnace on-line and it requires only a single viewport. However, care is required to ensure the viewport remains clear of sulphur and soot deposits which compromise the performance of the pyrometer.
