The Incident

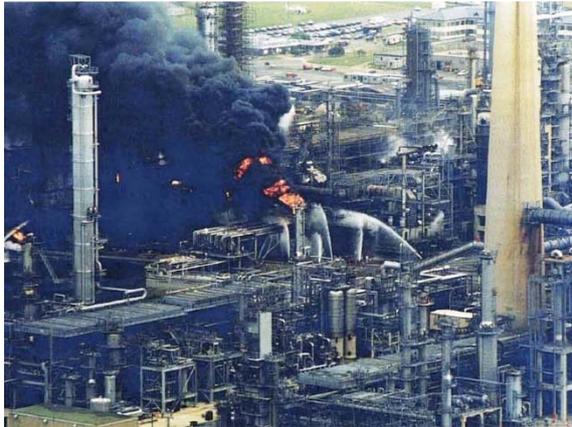
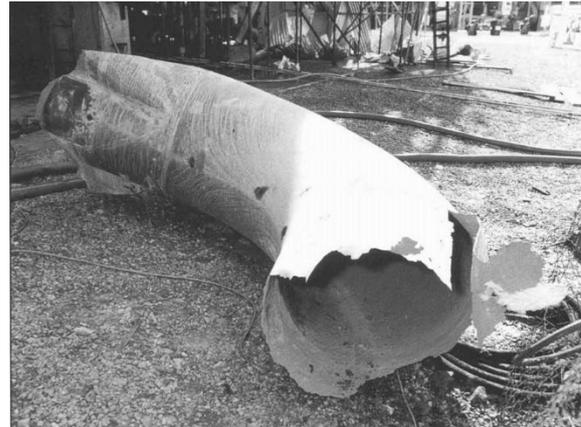
A lightning strike on the crude distillation unit (CDU) caused a fire which triggered a shutdown of the CDU and domino shutdowns of all other process units except for the fluid catalytic cracker (FCC). Approximately 5 hours later, the FCC flare knockout drum outlet line ruptured, releasing flammable hydrocarbons which found an ignition source some 110 m away and subsequently exploded. A major fire ensued at the FCC flare knockout drum and a number of secondary fires erupted in adjacent plant. The explosion had incapacitated the flare system so the fires were allowed to burn themselves out. The last of the fires was extinguished some 2½ days after the explosion. The site suffered severe damage to process plant, storage tanks and buildings. Properties in the nearest town 3 km away suffered some glass damage. The refinery remained shut down for some 9 weeks and took a further 9 weeks to reach full capacity.

The immediate cause of the explosion was loss of primary containment (LOPC) due to rupture of a corroded DN 750 (30" NS) elbow on the FCC flare knockout drum outlet line. Critical factors were failure of the FCC debutaniser level control valve and inability of the board operator to diagnose liquid overfill. Root causes included inadequate maintenance (plant and instrumentation), inadequate monitoring tools (control panel graphics did not provide necessary process overviews), inadequate warning systems (too many alarms, poorly prioritised), inadequate training (troubleshooting skills), inadequate risk assessment (supervisors failed to assess risk of continuing operation under extreme upset conditions) and inadequate Management of Change (WGC interstage KO drum temporary drain hoses).

Control panel graphics should provide a process overview including mass and heat balance data. Operators should be trained to properly interpret anomalous or inconsistent data. The number of alarms should be limited to a quantity that the operator can effectively monitor. Critical alarms should be highlighted and the required operator responses should be documented for each. All plant modifications (including emergencies) should undergo a formal hazard analysis.
