The Incident

During restart of the fluid catalytic cracker (FCC) after an electrical power failure, an operator noticed a hydrocarbon vapour leak in the unsaturated gas plant (USGP) section of the unit shortly after liquid transfer from the debutaniser column to the downstream rerun column had been initiated. The control board operator was notified and feed to the FCC was stopped. A few minutes later, while a team of operators was investigating and attempting to isolate the source of the leak, the vapour ignited and a major fire erupted. Fortunately, the operators escaped safely and a fire detector in the nearby hot oil pump house alerted the control board operator who immediately stopped feed to the USGP. The incident was attended by the on-site emergency services and the external fire brigade. The fire was brought under control within 90 minutes and the remaining hydrocarbon inventory was allowed to burn off. It was finally extinguished after a total duration of approximately 6½ hours. The FCC remained shut down for several weeks.

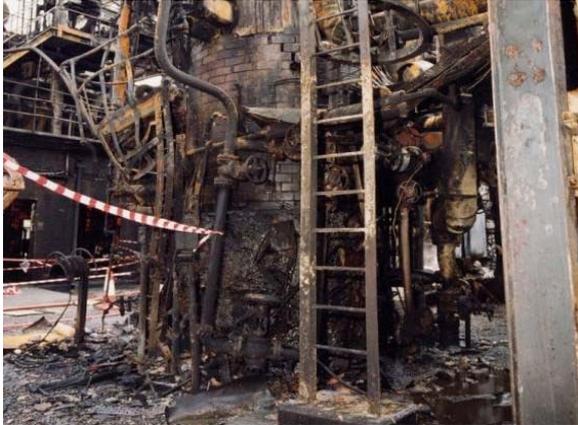
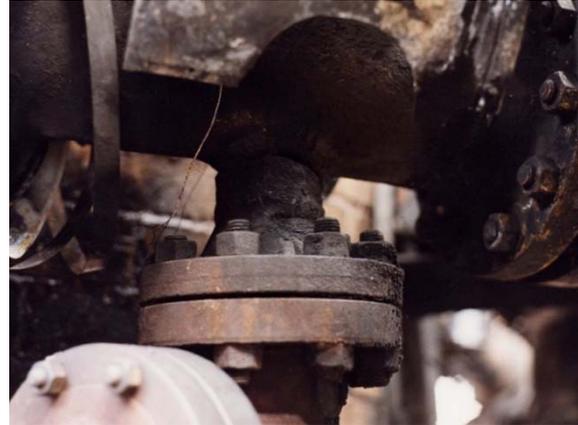
The debutaniser drain and pumpout systems share a section of DN 80 (3" NS) pipe suspended vertically from a branch on the underside of a DN 150 x 80 (6" x 3" NS) reducing tee located on the vessel side of the debutaniser bottoms isolation valve on the transfer line between the debutaniser and rerun columns. The vertical pipe connects to the branch of an equal tee. This tee originally had valves on both sides leading to the oily water sewer and pumpout systems, respectively, but the pumpout system had been disconnected from process some years earlier by removing and replacing the valve with blind flanges at the open ends. The failed reducing tee was later found to be a set-on type rather than the forged type called up in the original project piping specification (not visible as covered by insulation).

The immediate cause of the fire was a loss of primary containment (LOPC) from a DN 150 x 80 (6" x 3" NS) reducing tee branch on the transfer line between the debutaniser and rerun columns due to fatigue cracking and subsequent mechanical overload. The LOPC resulted in a release of highly flammable liquid/vapour at elevated temperature and pressure which ignited on contact with an uninsulated section of slurry pipe at the debutaniser reboiler. Critical factors included 1) high levels of cyclic stresses on the pipework (multiple FCC shutdowns and startups), 2) incorrect tee piece design (set-on instead of forged), 3) inadequate pipework support (tee piece provided only support after valve removed) and 4) inadequate inventory isolation within the USGP (extended duration of fire). Root causes included inadequate management of change (MoC), inadequate pipework inspection (dead legs and redundant pipe/fittings) and inadequate design (FCC converter revamp and lack of remote-operated shutoff valves between USGP columns).

Process hazard analyses should take account of abnormal conditions created by operational instability resulting from process/equipment unreliability. Remotely operated shutoff valves can minimise the impact of an uncontrolled leak.
