The Incident

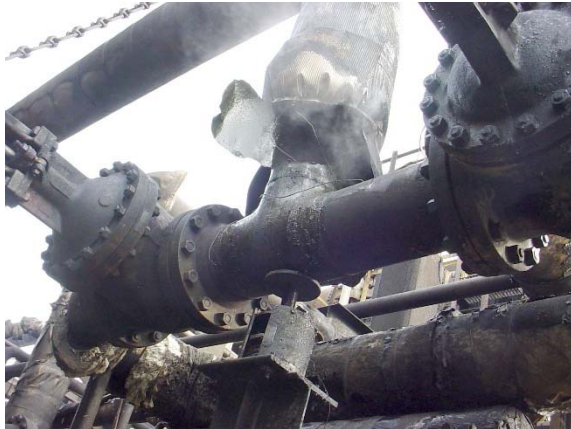
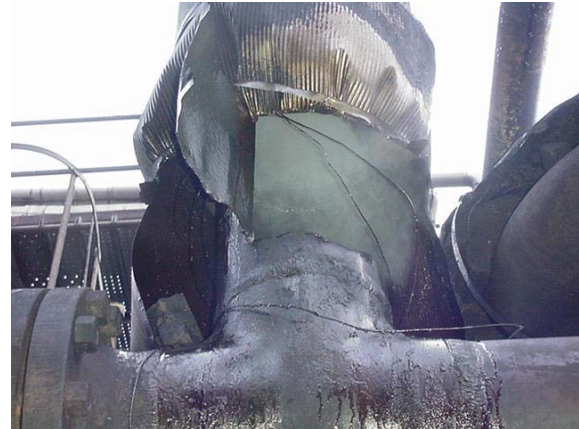
A suspected leak was observed on the tubeside (slurry) inlet line to 1 of 3 parallel trains of Slurry/Feed Preheat exchangers on a Fluid Catalytic Cracking (FCC) unit. The leak rate appeared to be increasing so two sets of operators were sent to isolate the leak using block valves upstream and downstream of the leak location. The downstream valve was closed successfully but the upstream valve could not be closed because the chainwheel broke off after just a couple of turns. Approximately 1 minute later, the pup piece ruptured, resulting in a heavy oil/vapour cloud release which ignited, causing a significant unit fire. The FCC throughput was quickly reduced and the release/fire was contained by the emergency response team until the breach was finally isolated from the process. Public roads downwind of the release were closed for a brief period as a precaution. The fire took approximately 42 minutes to extinguish. One employee sustained a minor first aid injury while evacuating the unit. Three personnel were examined at the emergency room as a precaution and released and 133 personnel were examined and decontaminated (on site) as a result of potential oil overspray.

Most of the piping in this circuit was installed in 1965 although there was no record indicating in which year the ruptured pup piece was installed. Metallurgical analysis revealed the pup piece was fabricated from carbon steel pipe with a silicon content of 0.03 – 0.04 wt% (ASTM A53). It had not been identified as a thickness measurement location (TML) as it was not shown on any drawings and could not be seen as the piping was insulated. However, the rupture location was less than 610 mm (24") away from a TML that was routinely monitored. Pipe and fittings immediately upstream of the pup piece had a silicon content of 0.07 – 0.25 wt% and had suffered much less thinning. The FCC unit had been running steadily for a couple of years prior to the incident with no significant operational upsets and had been running smoothly on the day of the incident. However, the total sulphur content of the feed to the FCC unit had gradually increased by approximately 20% since the end of 2000 as a result of refinery-wide optimisation activity.

The immediate cause of the rupture was high temperature sulphidic corrosion (HTSC) of an unmonitored low silicon carbon steel pup piece. A contributory factor was inability to close the inlet valve because the chainwheel came off (this caused the line to be isolated on the downstream side of the leak and impacted the extent of fire damage). Root causes included 1) inadequate material specifications (low silicon carbon steel), 2) failure to carry out a Management of Change (MOC) review to understand the impact of running high sulphur feedstocks, 3) inadequate communication with Inspection Department about the existence of the pup piece and the increase in FCC unit feed sulphur content, and 4) failure to learn lessons from other HTSC incidents at this and other refineries.

Sulphidation corrosion causes thinning over a relatively large area so failures tend to involve ruptures or large leaks rather than pinhole leaks. It can be insidious in that moderately high corrosion rates can go undetected for years before failure. Process changes that result in higher temperatures or sulphur content can creep up over time and multiply corrosion rates so that systems which historically had low corrosion rates can become corrosive enough to fail before the increased corrosion rate is recognised. The addition of silicon in the manufacturing process reduces the amount of oxygen in carbon steel ("silicon killed") and increases its resistance to HTSC. High chrome alloys offer excellent resistance to HTSC and are inherently safer than carbon steels when operating at temperatures above 260 °C (500 °F).
