The Incident

The channel head of a combined feed exchanger on a semi-regenerative catalytic reforming unit (CRU) failed catastrophically whilst it was being subjected to hydrostatic testing (“hydrotesting”) during turnaround. The intended hydrotest pressure was 140 barg (2036 psig), but the rupture occurred at only 93 barg (1350 psig). Fortunately, no one was injured, but the turnaround duration was extended by 20 days while the plant was modified to allow startup of the unit with the exchanger bypassed (the original exchanger train had no bypasses on either shellside or tubeside).

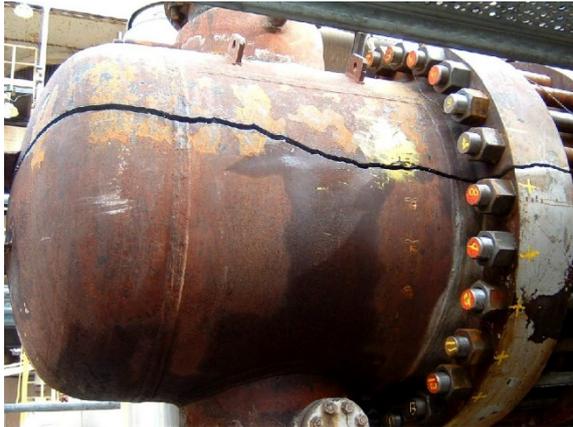
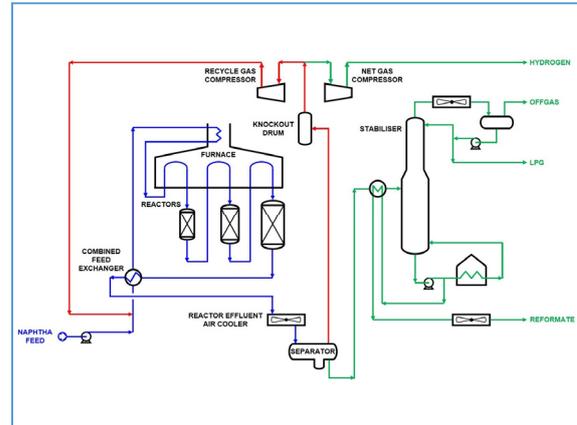
Visual inspection of the failed exchanger revealed that the channel head (“stationary head” or “bonnet”) flange had been out of alignment by approximately 3 mm. Metallurgical analysis revealed that the failure mechanism was brittle fracture. The channel head is fabricated from 40 mm thick 2.25 Cr/1.0 Mo plate (ASTM A387 Gr. 22 Cl. 2) and the main flange is fabricated from 195 mm thick 1.25 Cr/0.5 Mo (ASTM A182 Gr. F11). The exchanger was specified with a tubeside design pressure of 32.8 barg (475 psig) and a minimum acceptable water temperature for hydrotest of 6 °C (43 °F). The hydrotest water temperature at the time of this incident was approximately 20 °C (68 °F).

The immediate cause of the channel head failure was brittle fracture due to temper embrittlement. Uneven bolt torque and flange misalignment were contributing factors. Critical factors included the age, composition and thermal history of the steel (susceptibility to temper embrittlement) and inappropriate selection of the hydrotest pressure (full hydrotest pressure not required if only verifying tube-to-tubesheet joint integrity). The root cause was inadequate job knowledge.

Temper embrittlement cannot be detected by normal non-destructive testing (NDT) inspection techniques so all low alloy Cr-Mo equipment should be assumed to be at risk of brittle fracture through temper embrittlement until the ductile-to-brittle transition temperature has been exceeded. Internal pressures in susceptible equipment should not be allowed to exceed 25% of design pressure until the metal temperature exceeds the Minimum Pressurisation Temperature (MPT) for that equipment (MPT is a function of metal composition and service history).
