Catastrophic Heat Exchanger Failures

Guest Lecture, Cork Institute of Technology, 04-Oct-16

Peter Marsh
Director - XBP Refining Consultants Ltd.
(e-mail: peter.marsh@xbprefining.co.uk)

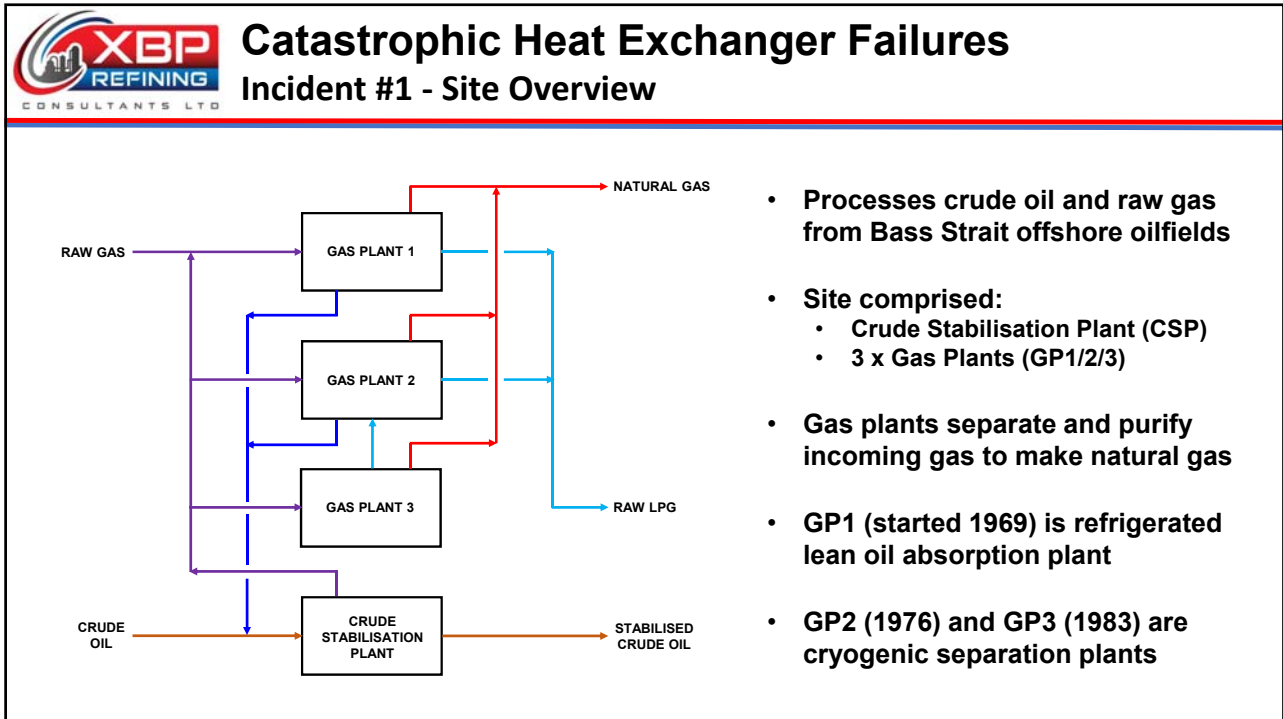
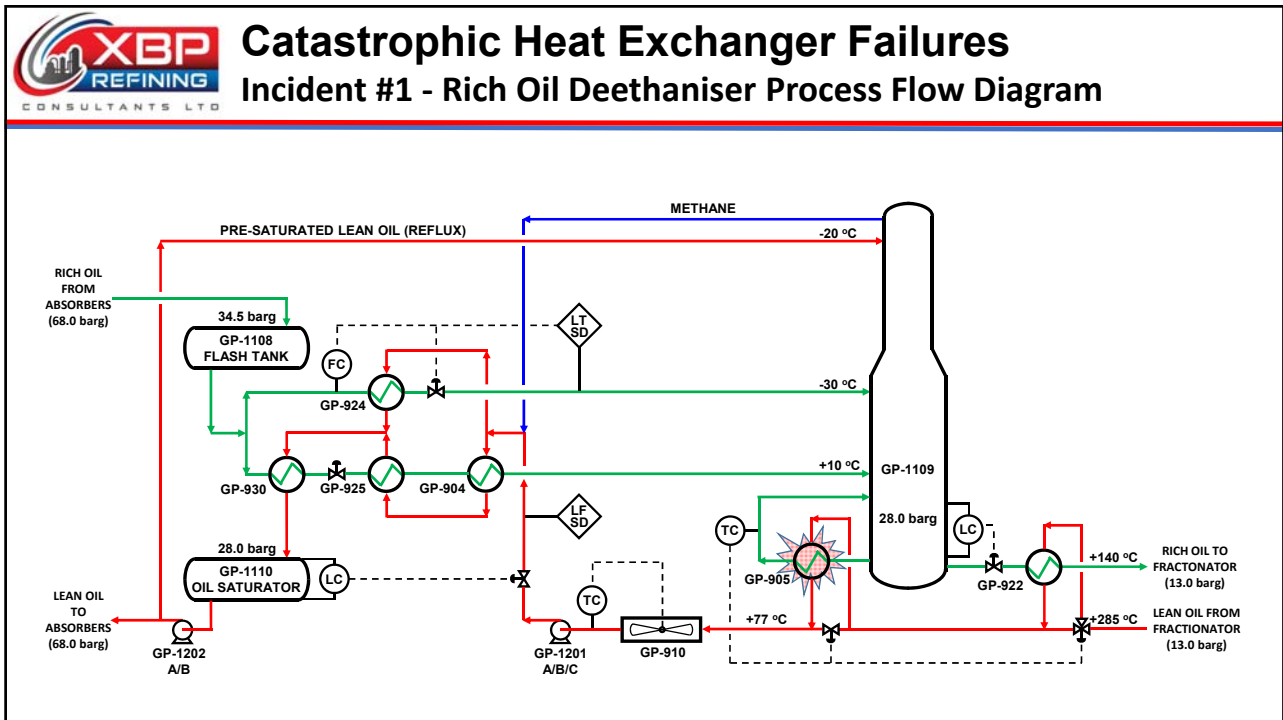
Catastrophic Heat Exchanger Failures
Incident #1 - Longford Gas Plant Explosion

- Incident occurred on 25-Sep-98 at Longford Plant (Gippsland, Victoria)
- 2 people died, 8 people injured, all natural gas supply from plant ceased
- Natural gas supply to state of Victoria severely affected for 2 weeks
- Consequential loss to industry estimated at A\$1.2 billion
- Homes without gas for cooking, water heating and home heating
- Incident investigated by Royal Commission (report published June 1999)

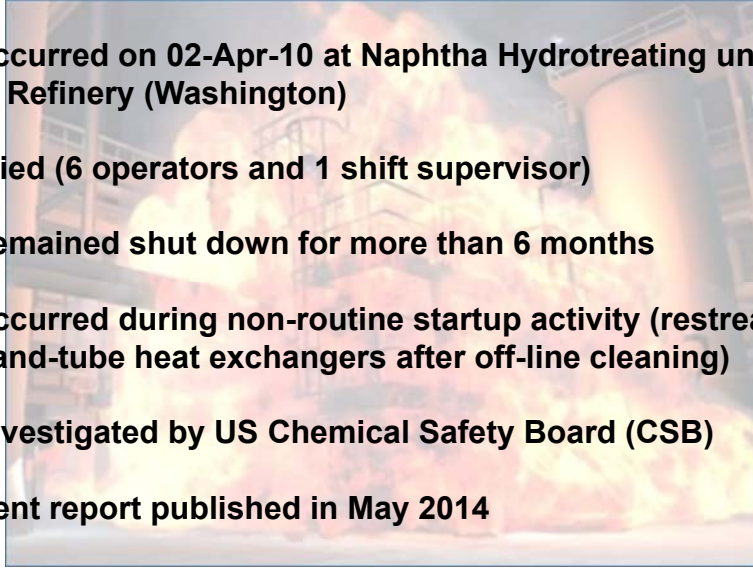
- Incident occurred on 02-Apr-10 at Naphtha Hydrotreating unit at Anacortes Refinery (Washington)
- 7 people died (6 operators and 1 shift supervisor)
- Refinery remained shut down for more than 6 months
- Incident occurred during non-routine startup activity (restreaming bank of 3 shell-and-tube heat exchangers after off-line cleaning)
- Incident investigated by US Chemical Safety Board (CSB)
- CSB incident report published in May 2014

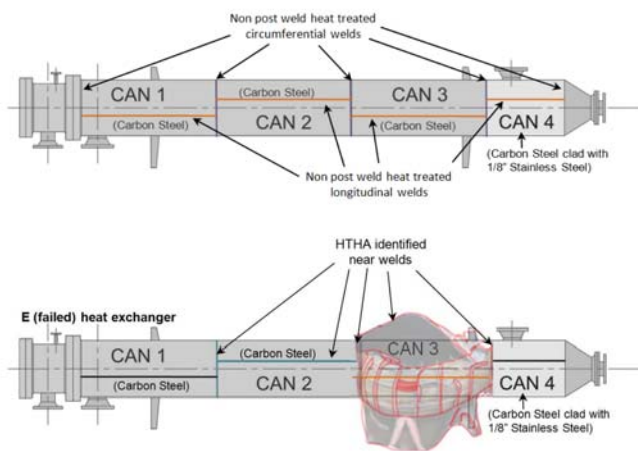
Incident #2 - Exchanger Construction

- Failed shell (and twin) were fabricated from carbon steel and partially clad with 316 SS
- Longitudinal & circumferential seam welds had not been post-weld heat treated
- Metallurgical analysis showed shell rupture caused by high temperature hydrogen attack
- Shell had been in service for 38 years when it failed

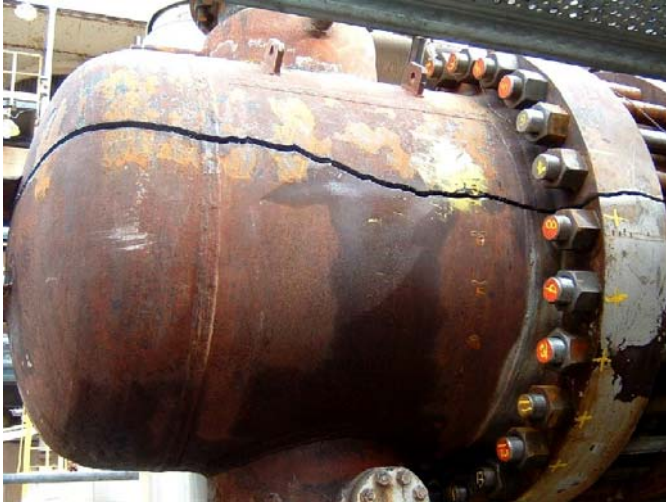
Incident #3 - Combined Feed Exchanger Channel Head Failure

- Semi-regen catalytic reformer combined feed exchanger
- Channel head failed during hydrostatic testing at well below intended test pressure
- Fortunately no injuries but restart delayed by 20 days
- Reactor feed on shellside, reactor effluent on tubeside
- Tube inlet service conditions ca 25.5 barg and 480 - 530 °C
