### The Incident

A large pool fire developed at the base of a dehexaniser (naphtha splitter) column. Fortunately, there were no injuries but there was significant fire damage to equipment and piping and a substantial opportunity cost (lost production) due to an extended unplanned outage while an investigation and repairs were carried out. The source of the leak was traced to a pipe rupture at the low point at the dead centre of the underside of a short horizontal section of the hydrotreated naphtha feed line close to the dehexaniser feed inlet nozzle.

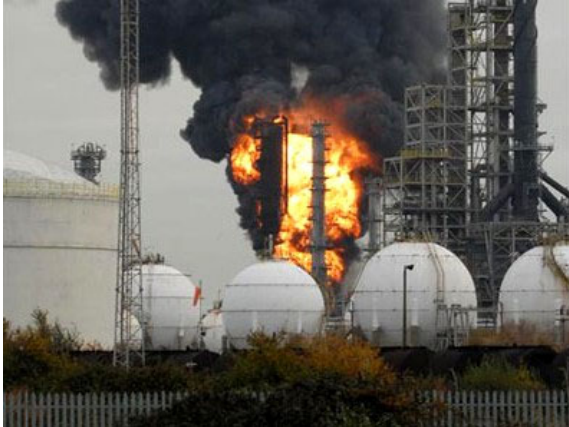
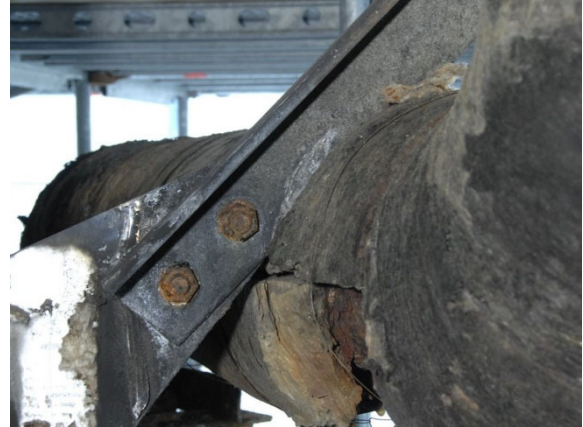
The immediate cause of the fire was over-pressure and rupture of the dehexaniser feed line at the low point of a short horizontal section due to reduced wall thickness caused by corrosion under insulation (CUI); the leaking preheated sweet naphtha pooled at the base of the column and the resulting vapour cloud found an ignition source. Critical factors included: 1) existence of a clash between the insulated pipe and a structural member supporting an access platform, 2) delivery of the dehexaniser column to site with the feed piping already installed and insulated but access platforms omitted (these had to be installed in the field due to limited headroom beneath elevated piperacks which would have precluded transportation of the column through the refinery on a self-propelled multi-axle trailer), and 3) the affected section of pipe was located in an obscure position (beneath the access platform and approximately 30 m or 98 ft above grade). Root causes included: 1) inadequate design (failure to comply with the project piping standard which required a minimum 25 mm or 1" clearance between the insulated pipe and a structural member), 2) inadequate correction of non-compliant pipe installation (insulation and cladding cut away to address the pipe vs structural member clash), and 3) inadequate inspection and preventative maintenance (weatherproof sealant perished or absent).

The concealed nature of CUI makes it difficult and expensive to detect. Inspection ports can be cut into the insulation to enable periodic on-line inspection. However, CUI generally occurs as pitting corrosion and can be quite localised, so inspection ports will only reveal a tiny fraction of the potentially affected metal service. Consequently, best CUI management practice should include most or all of the following elements: 1) application of an organic coating to susceptible carbon steel surfaces; 2) exclusion of water by careful insulation system design and installation; 3) periodic stripping, abrasive blasting, repainting, and re-insulating; and/or 4) periodic inspection and non-destructive evaluation.
