The Incident

A rim seal fire on a naphtha storage tank with an external (“open top”) floating roof escalated to a full surface fire within 2 hours after vapours which had leaked into pontoons exploded causing the floating roof to sink. A foam attack was launched soon after the fire alarm was sounded but this failed due to inability to deliver foam to the tank (water pressure too low). An attempt was made to pump naphtha out of the tank but this also failed (naphtha became too hot to pump). The fire was allowed to burn overnight and a new foam attack was launched the following morning with additional high-capacity firefighting equipment. The fire was finally extinguished later that afternoon (total duration of the fire was approximately 30½ hours). There were no injuries (except dehydration from the heat) and no adjacent storage tanks or process equipment was impacted.

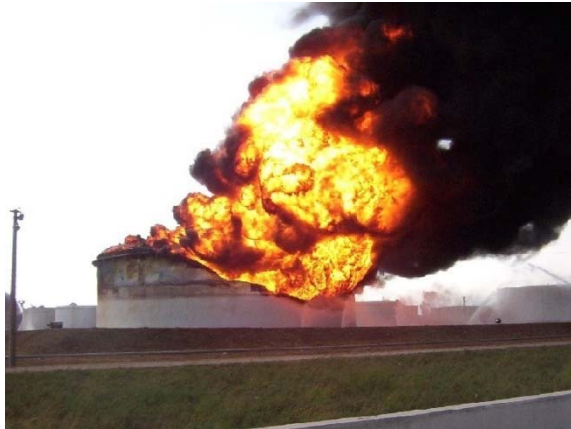
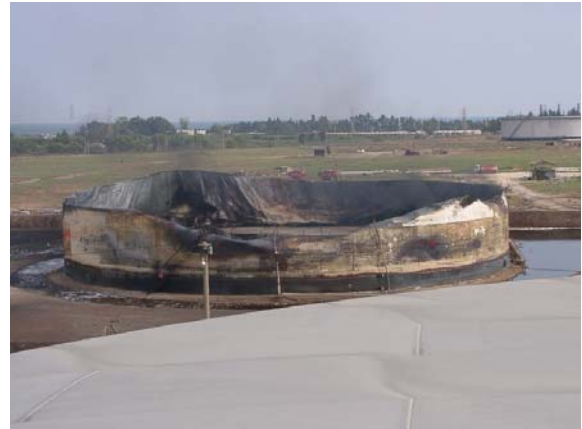
The immediate cause of the initial fire was ignition of the flammable atmosphere in the rim seal area by a frictional spark created when the jammed floating roof released suddenly as the tank contents were pumped out. The rapid escalation to a full surface fire was caused by the floating roof sinking after one or more roof deck pontoons exploded (corrosion enabled naphtha vapour to leak into pontoons). Critical factors included 1) a defective or derailed rolling ladder (which caused the floating roof to jam) and 2) inadequate rim seal fixed foam pourers and inadequate immediate water pressure (these two factors extended the duration of the fire). The root causes were inadequate risk assessment of storing high TVP naphtha in a floating roof tank, inadequate inspection (failure to conduct routine explosimeter tests on the atmosphere inside the roof deck pontoons) and inadequate risk assessment of previous roof deck problems.

Rim seal fires can quickly escalate into a full surface fire if the roof deck pontoons of a floating roof tank are leaking. Therefore, regular (at least 6 monthly) inspections should be carried out on all pontoons including explosimeter testing to determine if any of them contain a flammable atmosphere. Note that for a typical pontoon of 10 m³ (353 ft³) volume, a leak of just 0.8 litres (0.21 USgal) of gasoline will be enough to enable the atmosphere to reach the lower explosive limit (LEL). Rim seal fixed foam pourers should be regularly tested to verify they produce a good quality foam meeting the requirements of NFPA 11. The maximum recommended TVP for liquid products stored in single deck floating roof tanks is 76.5 kPa (11.1 psia). Exceeding this limit may result in vapour pockets collecting under the roof which can cause it to tilt, releasing vapour and increasing the risk of fire and/or sinking of the floating roof.
