The Incident

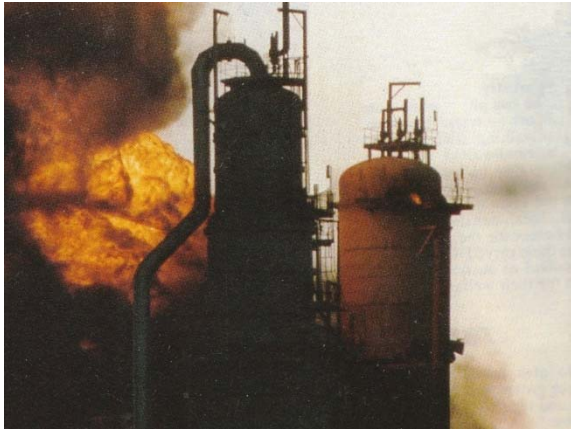
During a restart of the hydrocracker unit (HCU), the low pressure (LP) separator vessel suffered an explosive failure releasing the vapour and liquid contents of the vessel to atmosphere as a cloud or mist which subsequently ignited. This caused a fireball and blast effects due to the semi-confined nature of the plant and a contract crane driver in the vicinity was killed. The force generated by the explosion was equivalent to 90 kg (198 lb) of TNT and large fragments from the disintegrated vessel were projected over 1 km (0.6 miles) away. Fortunately, none of the fragments hit any personnel or vulnerable plant. Waxy material from ruptured pipework blocked drains, causing firewater to accumulate in a large pool. Leaking petroleum spirit spread over a large area of the pooled water and ignited some 5 hours after the initial explosion, engulfing a number of adjacent process units on the hydrocracker complex in flames. Fortunately, the incident occurred on a Sunday morning when there were far fewer personnel on site than a normal weekday.

The investigation found that the liquid level in the upstream high pressure (HP) separator had drained away through 1 of 2 flow control valves configured in parallel on its liquid outlet line. Two low low (“extra-low”) level switches on the HP separator were considered unreliable because wax often solidified in their small bore piping and float chambers in cold weather. The trip mechanism that was supposed to act on the parallel flow control valves in case of extra-low level had been deliberately disconnected some years earlier. The horizontal LP separator vessel had a single pressure safety valve (PSV) which operated correctly at its set pressure of 10.7 barg (160 psig). However, it had not been designed for a gas breakthrough case because the extra-low level trip system was intended to preclude this possibility. Metallurgical examination found that LP separator rupture originated in the heat affected zone (HAZ) of a saddle weld on the underside of the vessel. This meant the blast was directed downwards with fragments projected upwards.

The immediate cause of the explosion was a loss of primary containment (LOPC) due to overpressure and subsequent catastrophic failure of the LP separator vessel due to gas breakthrough from the upstream HP separator vessel. Critical factors included 1) the alarms on the HP separator extra-low level detection system failed (operators not alerted to imminent danger), 2) the low level trip system on the HP separator had been deliberately taken out of service (no automatic shutoff capability on liquid outlet) and 3) the gas outlet line on the HP separator was isolated (valved closed) while the HCU was on standby with no feed to the unit (PSV was only available route for gas disposal). Root causes included inadequate risk assessment, failure to conduct a proper Management of Change (MOC) review, inadequate design of liquid shutoff system (independent extra-low level detection and secondary shutoff valve), inadequate design of PSV (not sized for gas breakthrough) and inadequate heat tracing and insulation (extra-low level switches).

Trip systems should only be disconnected after careful risk assessment and an MOC review have been completed to verify that alternative means are in place to adequately control the associated hazards. The basis for the risk assessment should be properly documented and highlight any conditions affecting validity of the change (eg. maximum duration).
