N. American Site #2 - Vacuum Distillation Unit (VDU) Vacuum Residue Recirculation Line Rupture

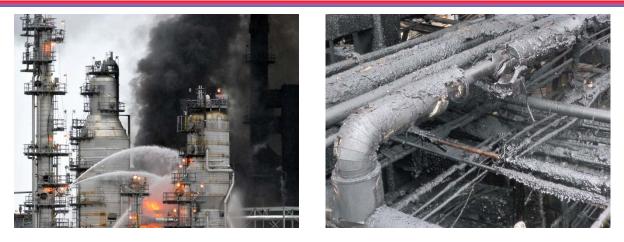
An emergency shutdown of the vacuum distillation unit (VDU) and the adjacent crude distillation unit (CDU) was manually initiated following rupture of a section of the vacuum residue recirculation line. The rupture resulted in a release of hot vacuum residue under pressure and above its auto-ignition temperature. A major fire erupted, causing damage to adjacent process equipment, piping and instrument cabling. The last flames were finally extinguished after approximately 1 hour and 43 minutes. Fortunately, there were no injuries but the CDU/VDU and several other units remained shut down for approximately 11 weeks while the necessary repairs were completed.

The recirculation line is fabricated from DN 150 (6" NS) 9 Cr/1 Mo pipe (ASTM A335 Gr. P9) and is electrically heat traced and insulated. The rupture occurred close to the inlet end at the top of the pipe in a horizontal, straight section above a pipe shoe. The release continued to feed the fire for 36 minutes; initially from the vacuum residue pump (until the vacuum tower level control valve closed, isolating the pump discharge) and then by reverse flow from the coker (until the leak source had been identified and isolated). Inspection of the ruptured pipe section revealed much greater thinning on top of the pipe than the bottom and a smooth transition in wall thickness from top to bottom with no discontinuities or pitting. Computational fluid dynamics (CFD) revealed the presence of a natural thermosyphon action in the line. The tracing was triple-wrapped at the rupture location due to the pipe shoe (two cables on top and one below). The tracing temperature set point was 190 °C (374 °F) but the sensor was located at a low point in the line.

The immediate cause of the fire was loss of primary containment (LOPC) due to rupture of the vacuum residue recirculation line as a result of thinning caused by high temperature sulphidation corrosion (HTSC). Critical factors included backflow of vacuum residue from the coker (extended duration of fire), thermosyphon action at the open-to-process end of the recirculation line (maintained high enough temperature to enable thermal cracking and replenished sulphur supply) and localised overheating (triple-wrapped heat tracing at rupture location and remote location of tracing temperature sensor). Root causes included inadequate job knowledge (potential for thermal cracking was not realised so thickness measurement locations were not specified where high temperature vapour may accumulate), inadequate procedures (shutdown procedure did not isolate feeds entering the unit from other units or tankage) and inadequate design (absence of emergency shutdown system and remote-operated battery limit isolation valves).

Sulphidation corrosion (also known as sulphidic corrosion) is a result of naturally occurring sulphur compounds found in crude oils. In the absence of hydrogen, the rate of sulphidation corrosion depends on many factors such as the concentration and type of sulphur compounds present and the fluid temperature and flow rate. Hydrogen sulphide (H_2S) is the most active sulphur species from a corrosion perspective and sulphidation corrosion rates increase rapidly above 260 °C (500 °F). The HTSC rate can be up to 6 times faster in the vapour phase than the liquid phase.
