Catastrophic Heat Exchanger Failures

Guest Lecture, Cork Institute of Technology, 04-Oct-16

Peter Marsh
Director - XBP Refining Consultants Ltd.
(e-mail: peter.marsh@xbprefining.co.uk)

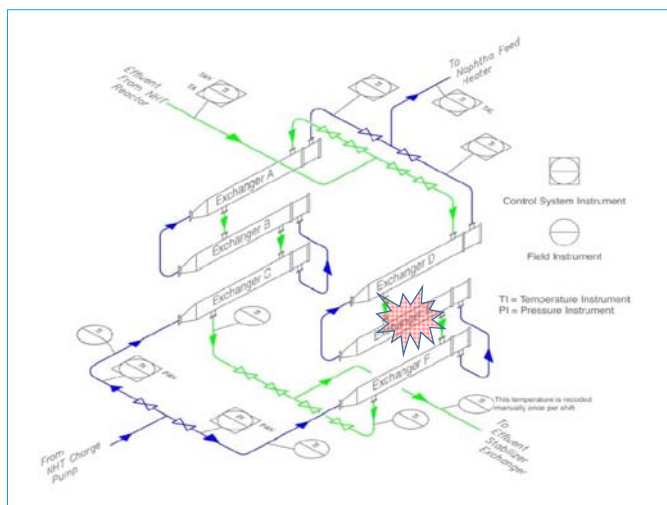
Incident #2 - Piping Isometric Diagram

- Isometric shows inlet and outlet temperature and pressure sensors
- Some measurements displayed at control panel via distributed control system (DCS)
- Some measurements displayed in field only
- No instrumentation on inlet or outlet streams of intermediate shells

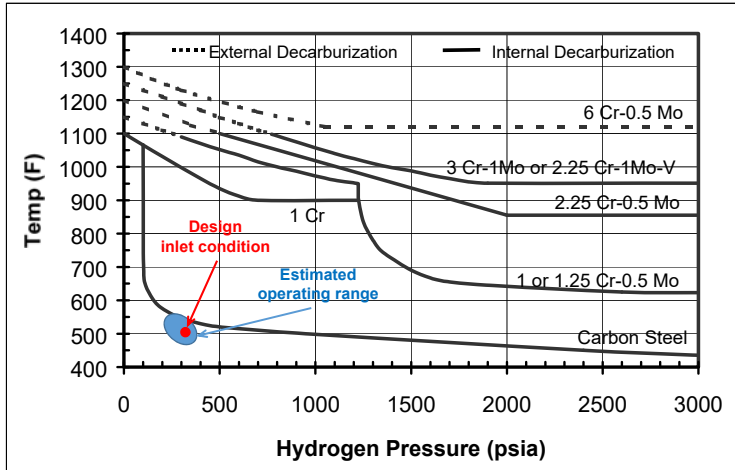
Catastrophic Heat Exchanger Failures Incident #2 - API RP 941 Nelson Curves

- Nelson curves provide limits on temperature and hydrogen partial pressure for carbon and alloy steels
- Curves are empirical based on experience
- Apply safety margin for both parameters;
28 °C (50 °F)
3.5 bar (50 psi)

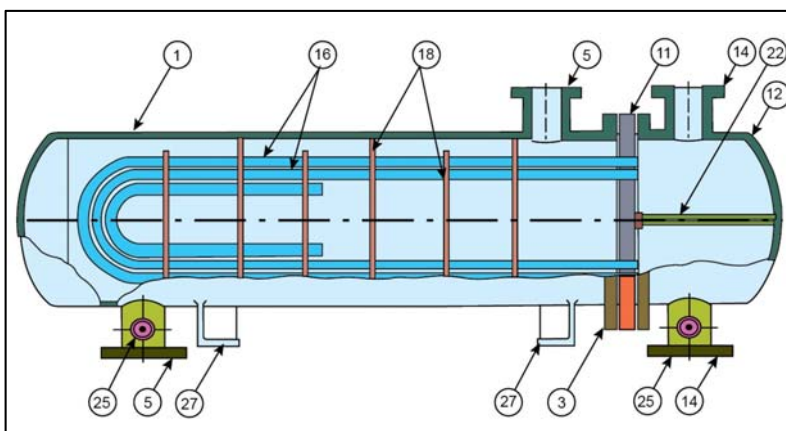
Catastrophic Heat Exchanger Failures Incident #3 - Combined Feed Exchanger Construction

- Exchanger was specified as TEMA Type BEU with strength-welded tubes
