## The Incident

On 25-Sep-98, a major upset occurred on Gas Plant 1 (GP1) at the Longford Plant in Gippsland, Victoria (Australia). GP1 was taken off-line and a few hours later, the rich oil deethaniser reboiler (GP-905) had become intensely cold and failed catastrophically when warm lean oil was re-introduced during restart. The failure released more than 10 tonnes of hydrocarbon vapour to atmosphere. The vapour cloud drifted some 170 m to a set of fired heaters and ignited. The flame front from the resulting deflagration burned through the cloud without causing an explosion. When it reached the ruptured exchanger, a fierce jet fire developed beneath an elevated piperack junction and flame impingement caused 3 more leaks. The resulting fire burned for more than 2 days. Two employees were killed and eight more were injured. Supplies of natural gas to domestic and industrial users throughout the state were halted for more than 2 weeks causing substantial losses to industry and massive inconvenience to people in their homes.

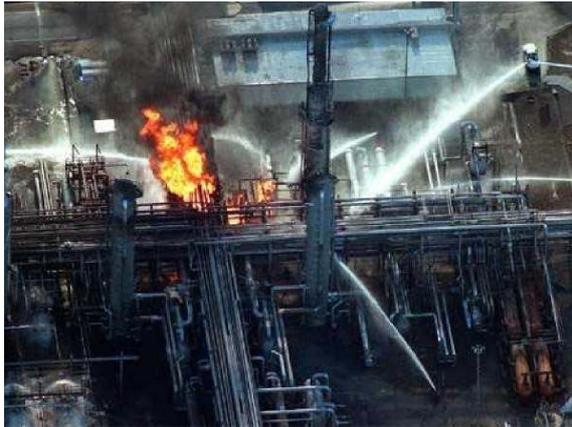
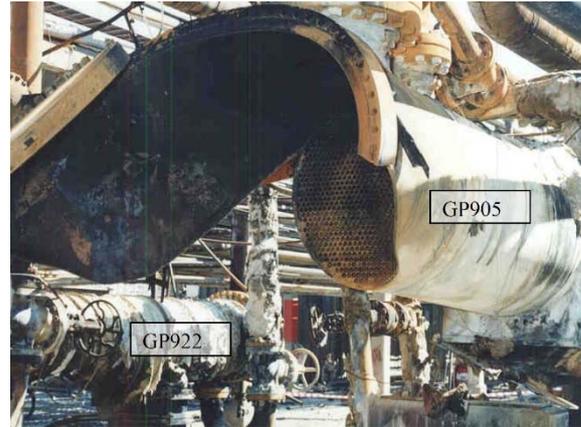
On the day of the incident, an increase in raw gas flow caused a buildup of condensate in 1 of 2 parallel absorbers at GP1 and then an upset in the rich oil deethaniser (ROD). The upset caused the lean oil pumps to trip, resulting in a loss of warm lean oil flow to the ROD reboiler (GP-905). The pumps could not be restarted and the loss of lean oil inflow to the oil saturator tank caused rapid drawdown of the level in the tank which initiated an automatic trip of the high-head lean oil booster pumps feeding the absorbers and total loss of lean oil circulation. Meanwhile, the continuing buildup of condensate in one absorber resulted in condensate carryover to the rich oil system. The extended period without lean oil circulation resulted in the rich oil stream gradually being replaced by pure condensate. As this stream flashed across the pressure letdown valves on the rich oil outlet from the lean oil absorber, the feed to the rich oil flash tank dropped to  $-42\text{ }^{\circ}\text{C}$  ( $-44\text{ }^{\circ}\text{F}$ ) and the feed to the rich oil deethaniser dropped to  $-48\text{ }^{\circ}\text{C}$  ( $-54\text{ }^{\circ}\text{F}$ ). Metallurgical analysis of GP-905 showed that the tubesheet to channel weld had slowly cracked due to radial expansion of the tubesheet but the crack rapidly propagated through the embrittled channel causing the channel end to rip open.
